1942 Ford

Well worn 1942 Ford Tudor Sedan.

By Mark Kicsak

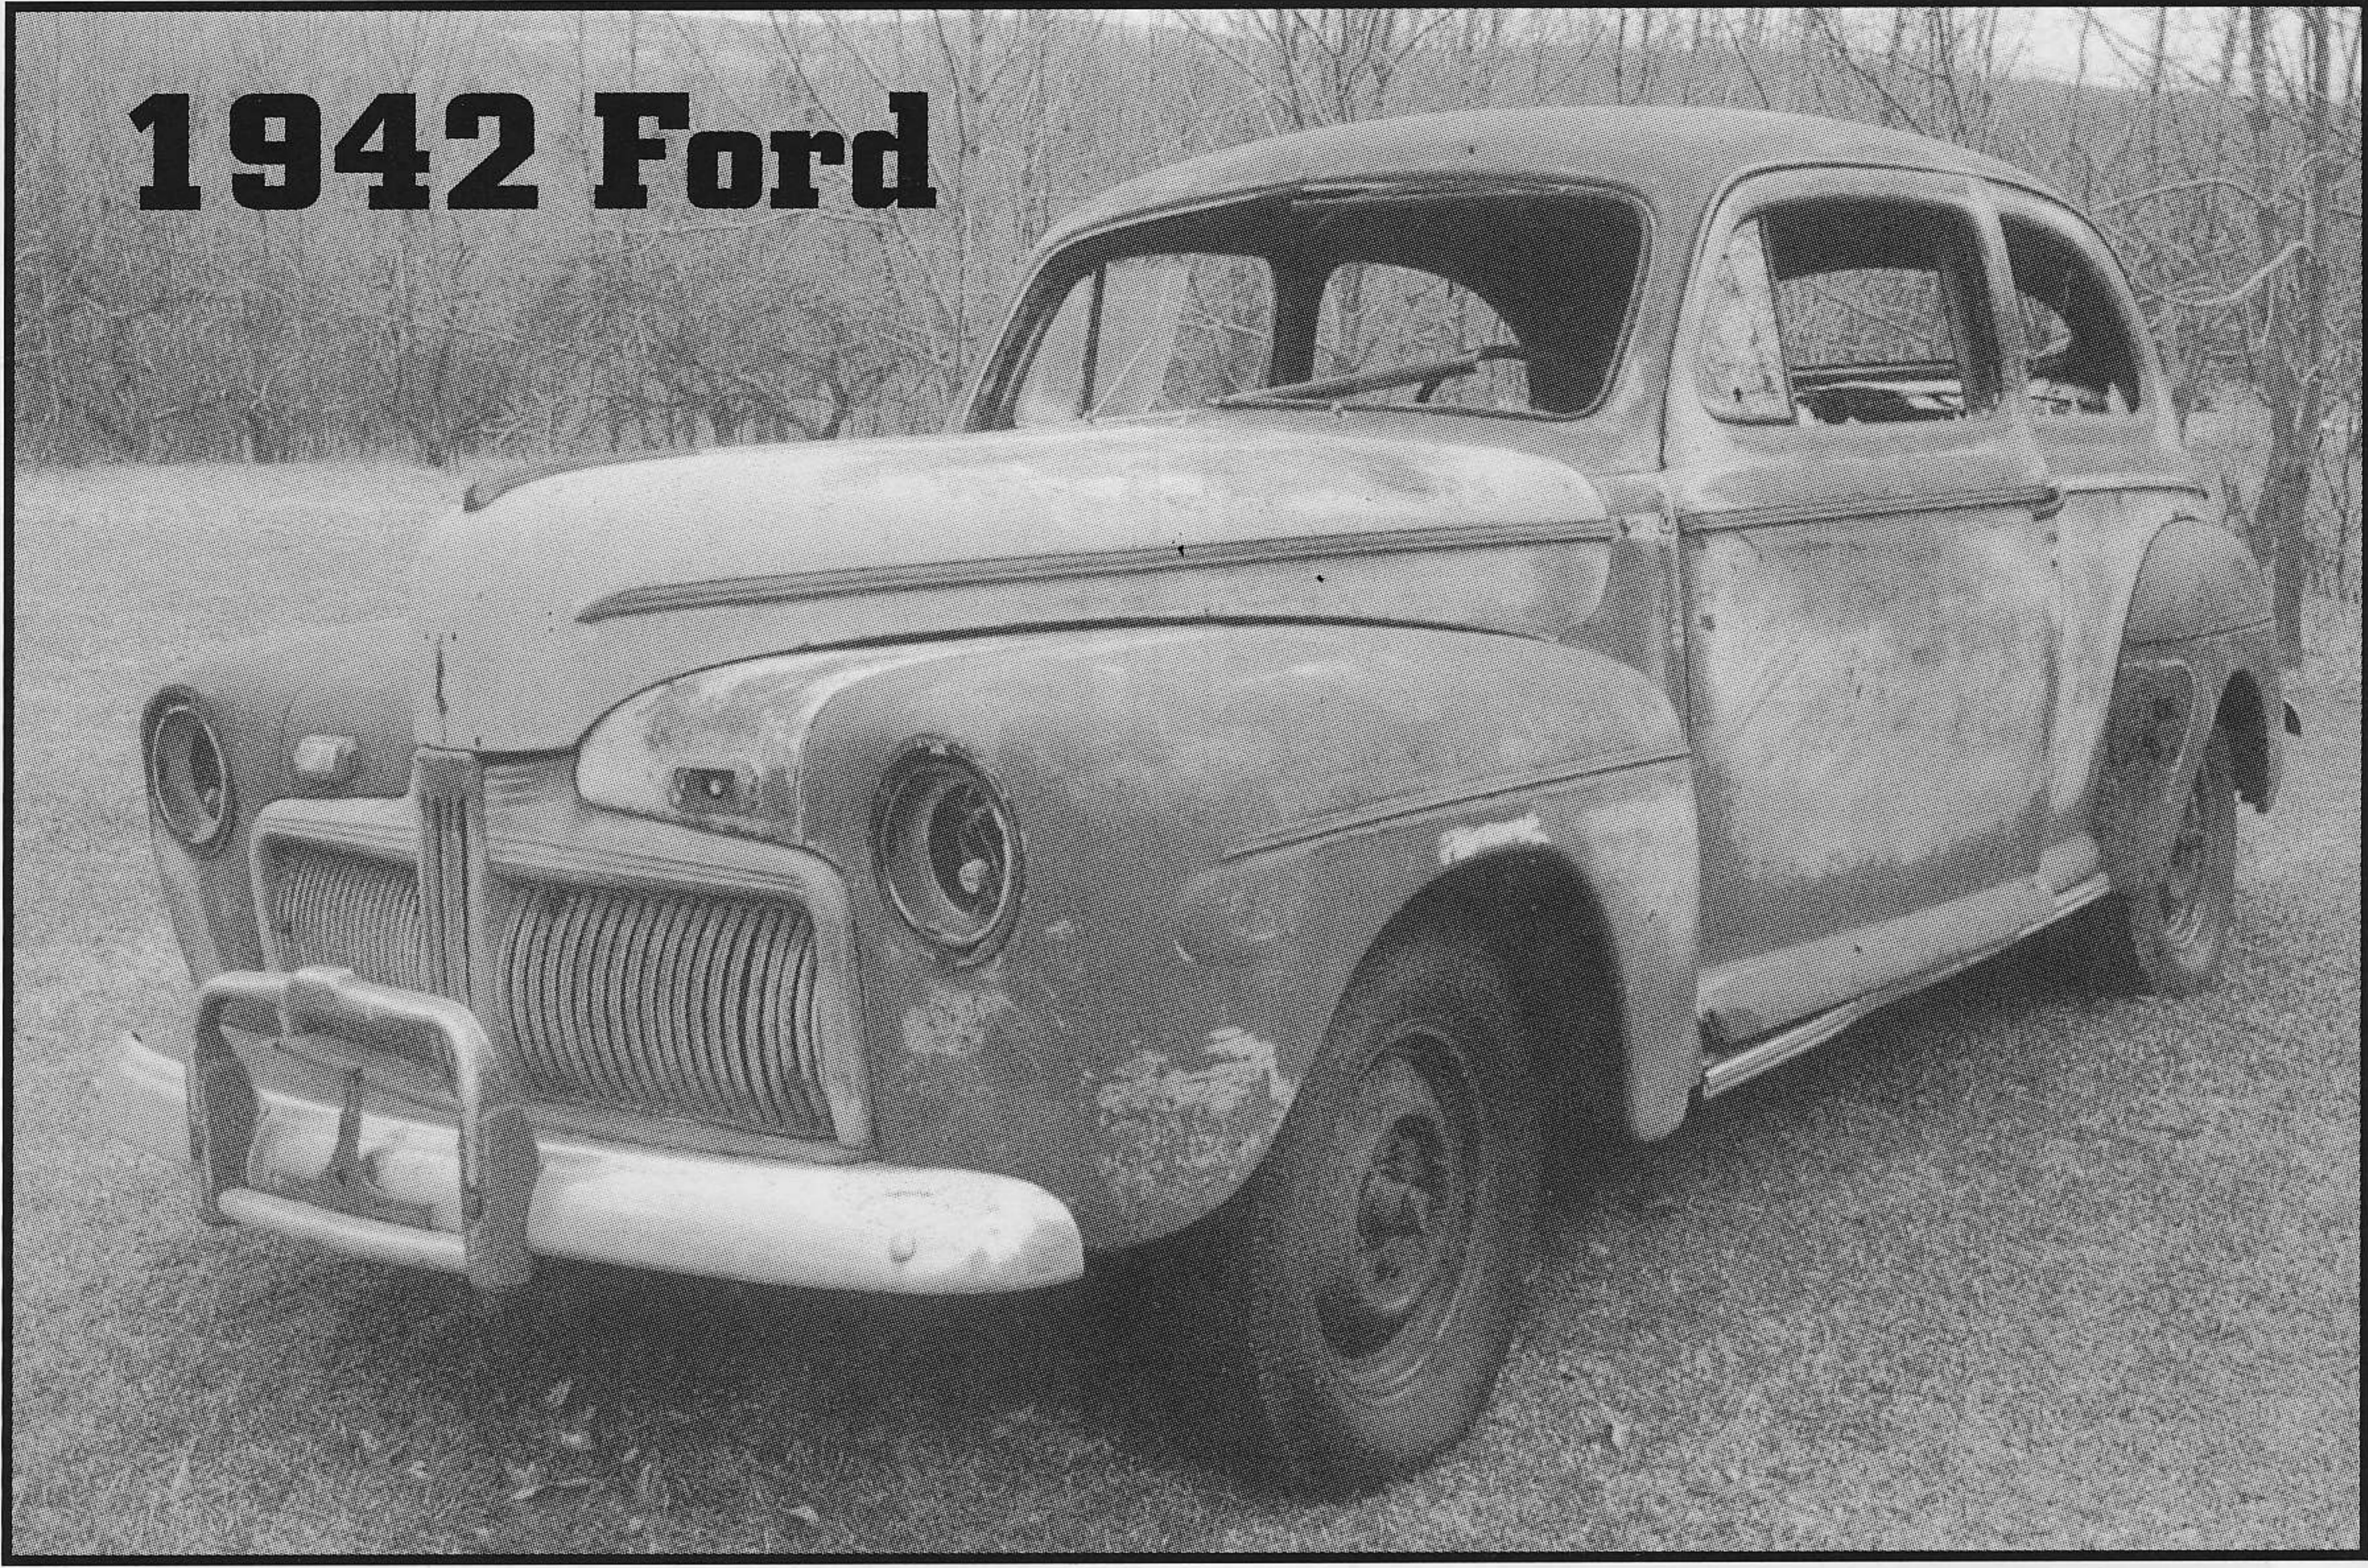
Looking at the front view of the drivers side, you will notice the rusty trim. What you may not notice is that the grill is zinc plated. If the picture clarity is good enough you can also observe that the hood ornament, outside windshield division strip, and perimeter windshield molding were plated.

On the passenger side of the car can be seen evidence of plating on the running board molding and the divider between the vent window and door glass. Both vent window frames exhibit plating too, but that can only be seen from inside. I believe this '42 to be a Super Deluxe, but it has no

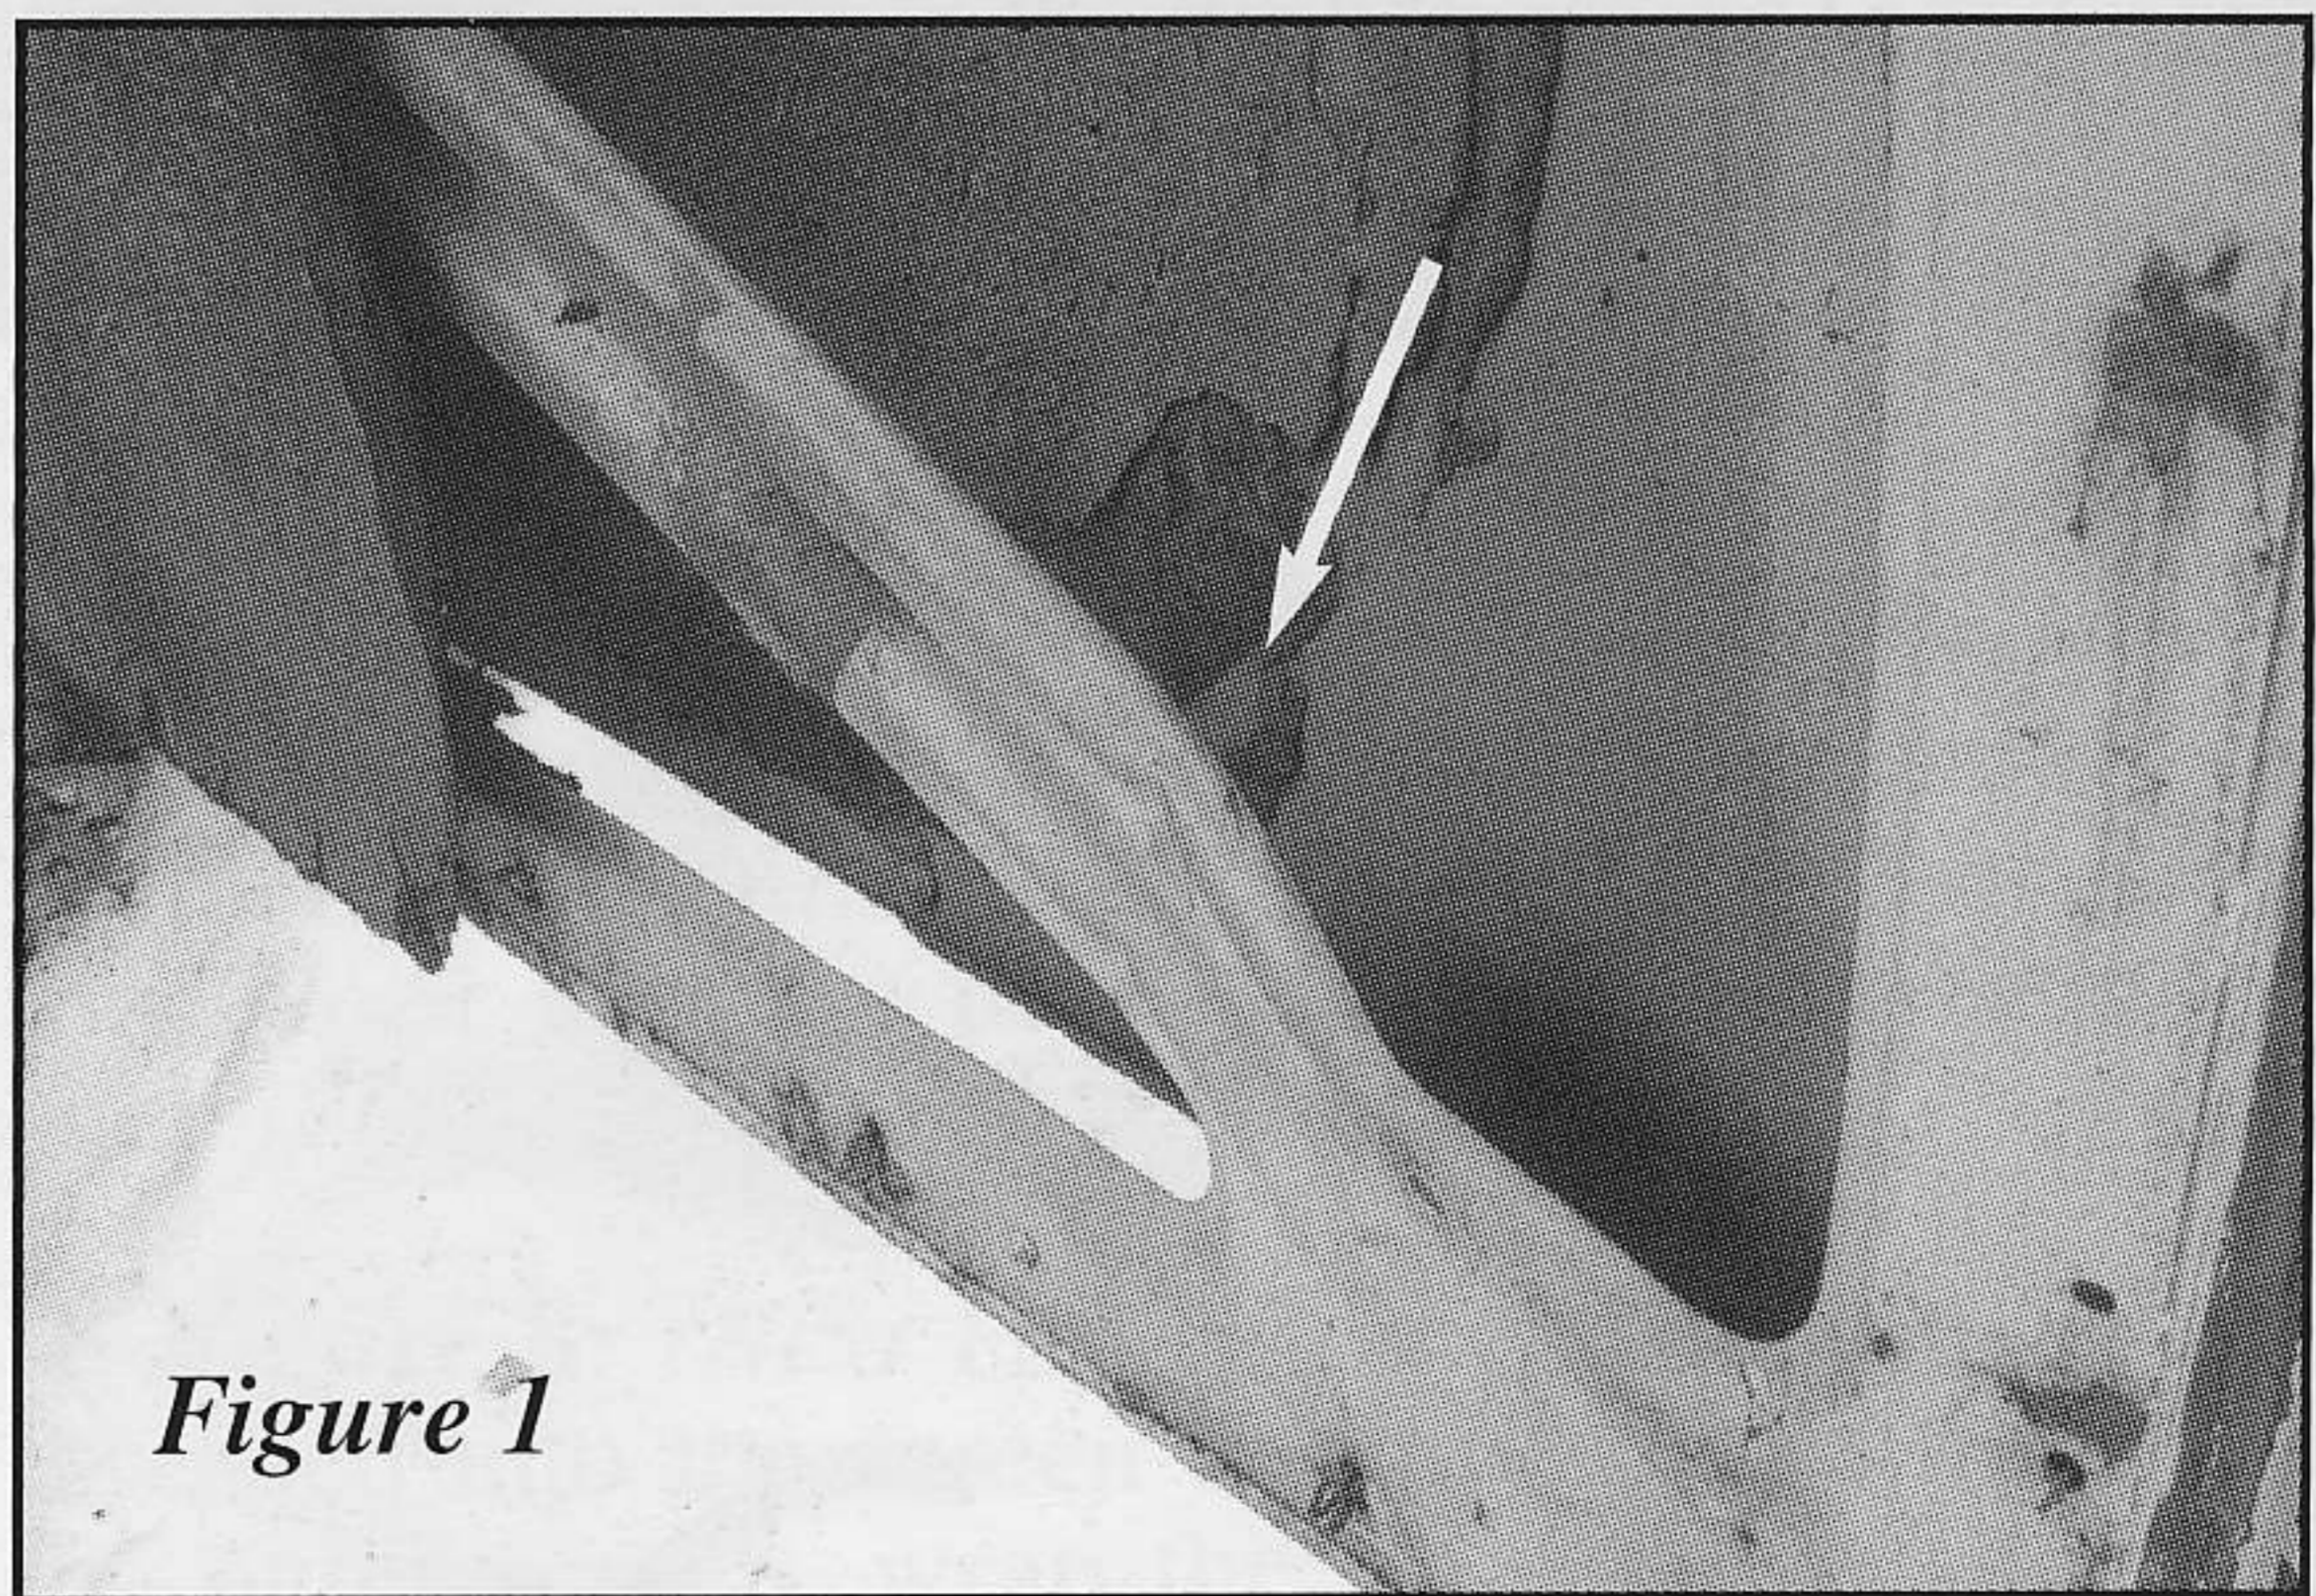
Figure 1

One of the things I tried to do was straighten a rather large dent on the inside door, frame. A similar dent is shown in **Figure 1 (Previous Page)**.

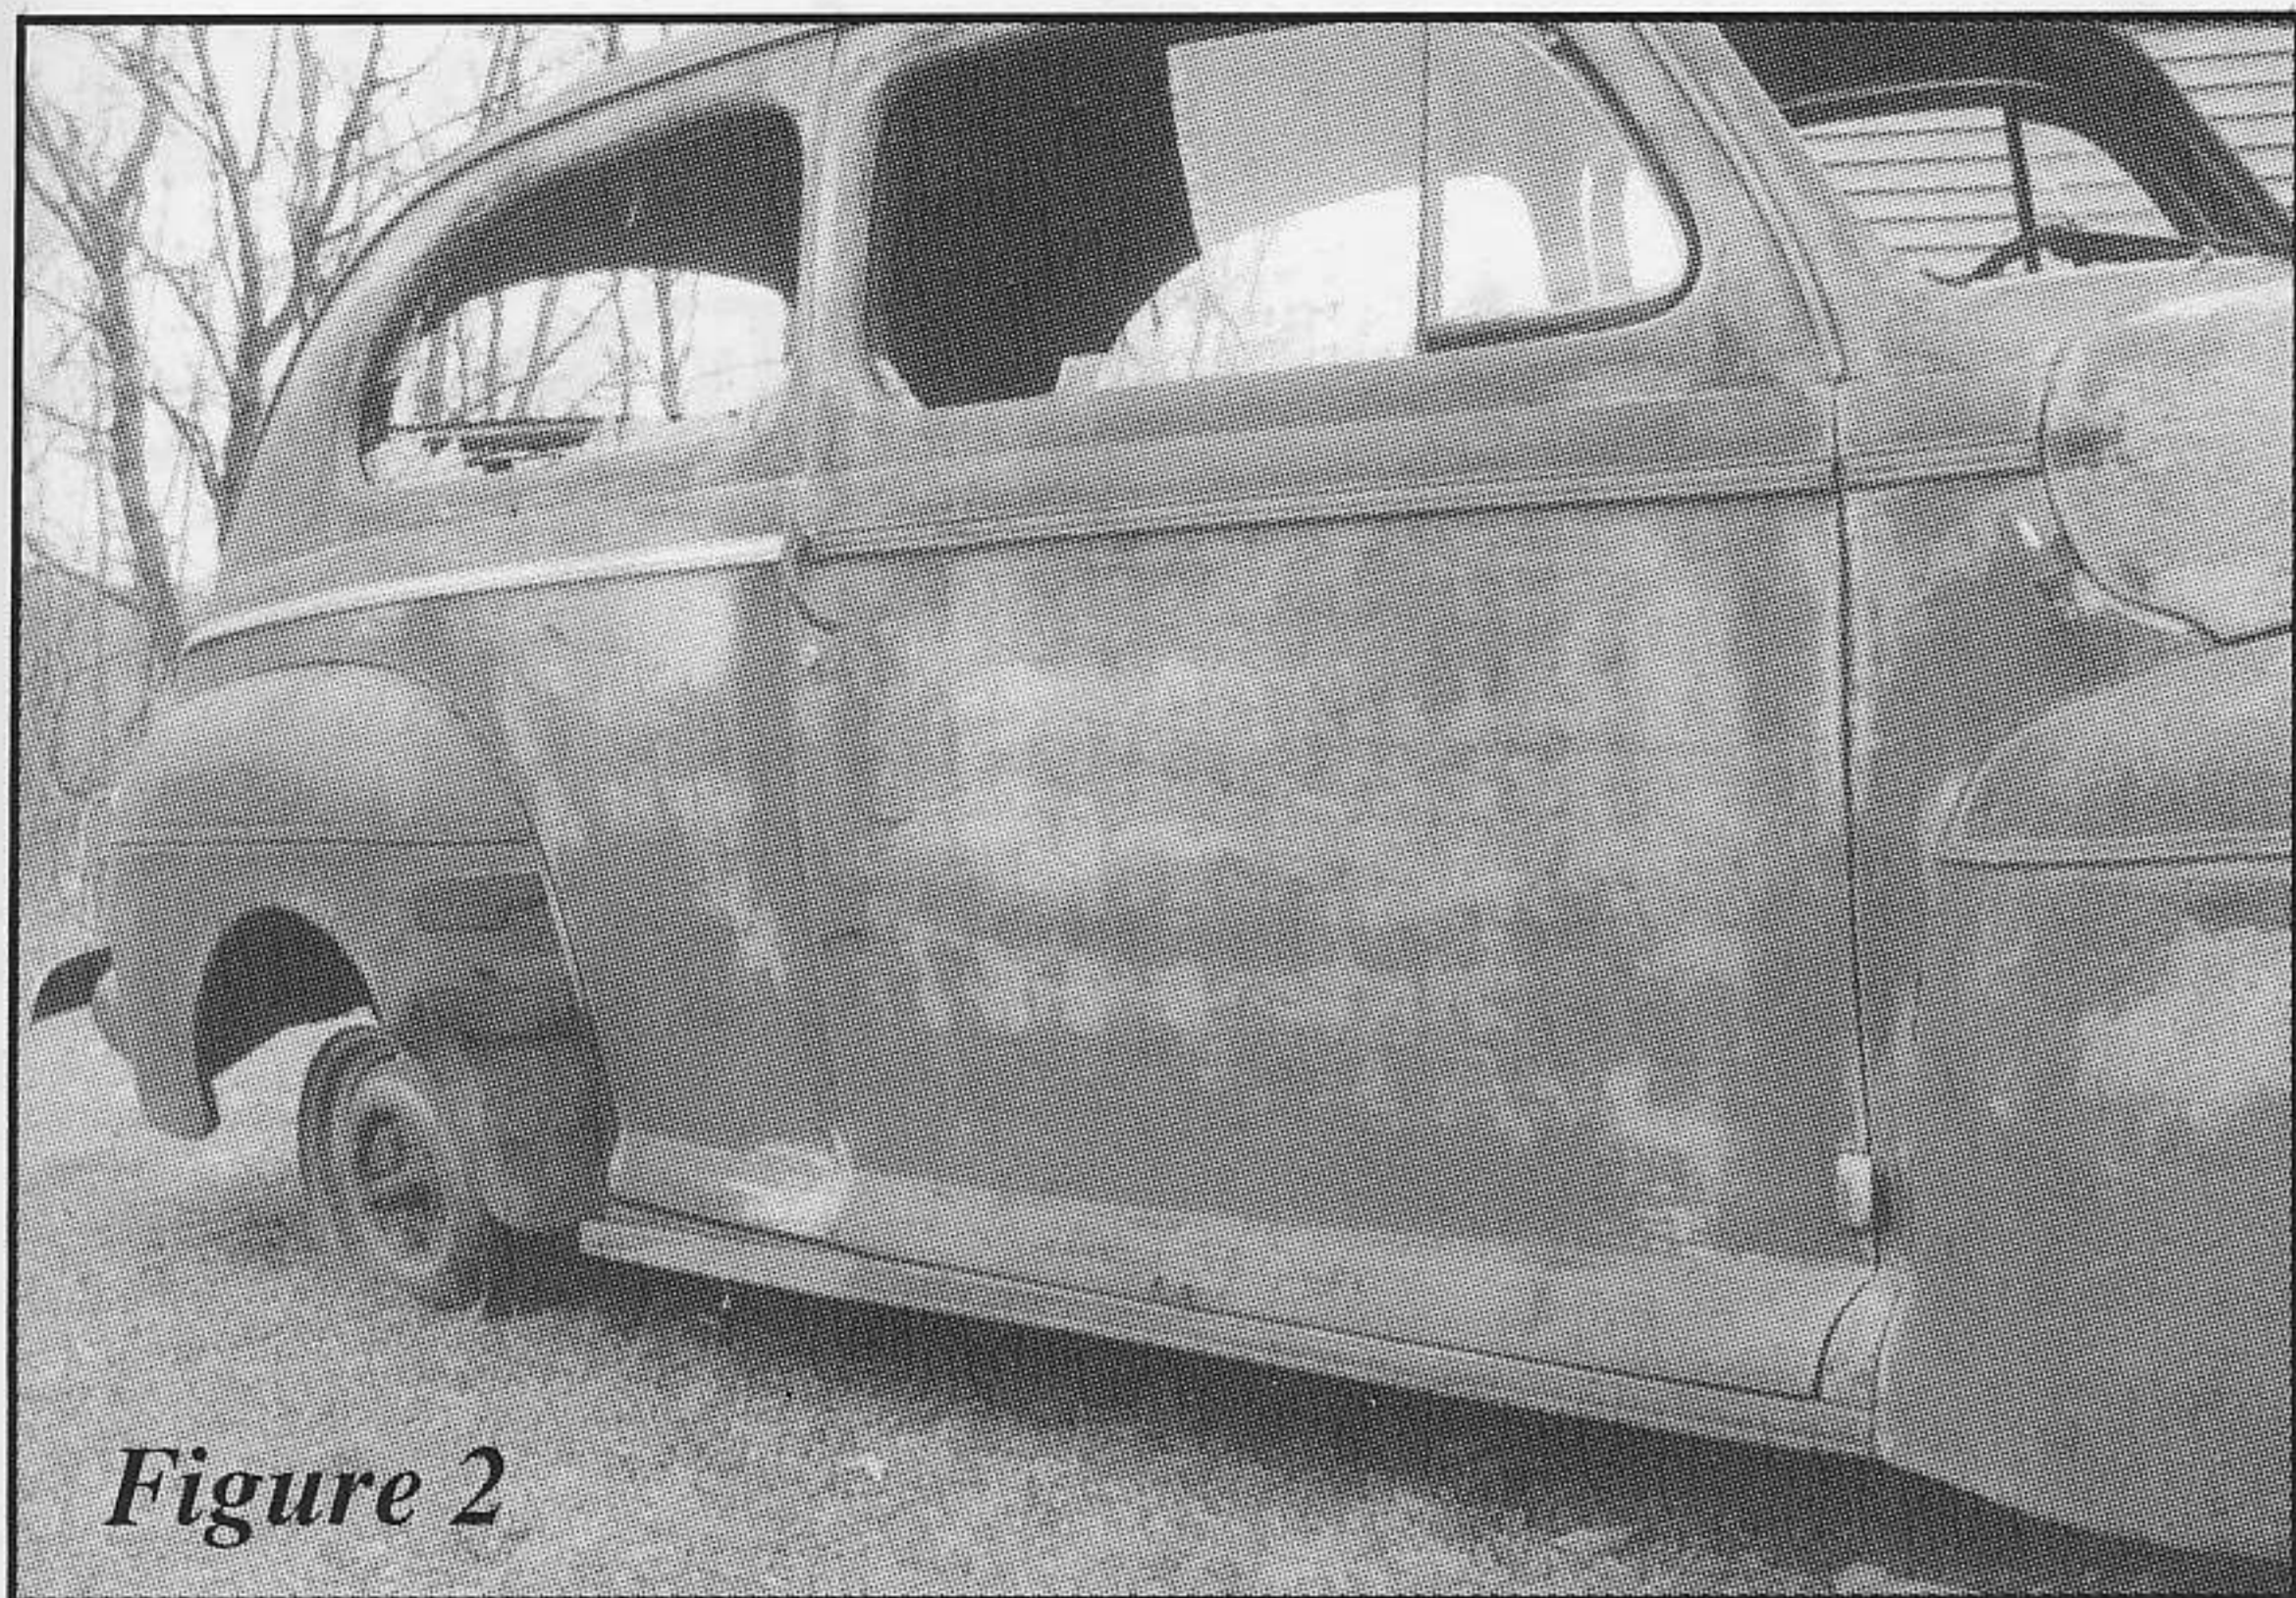
Figure 2

Example of good door alignment.

That brace is bent for a reason and the reason is shown in **Figure 2**. The bend effectively shortens the brace and by doing so, draws the bottom of the door in alignment with the body. The door in **Figure 2** lines up well with the body.

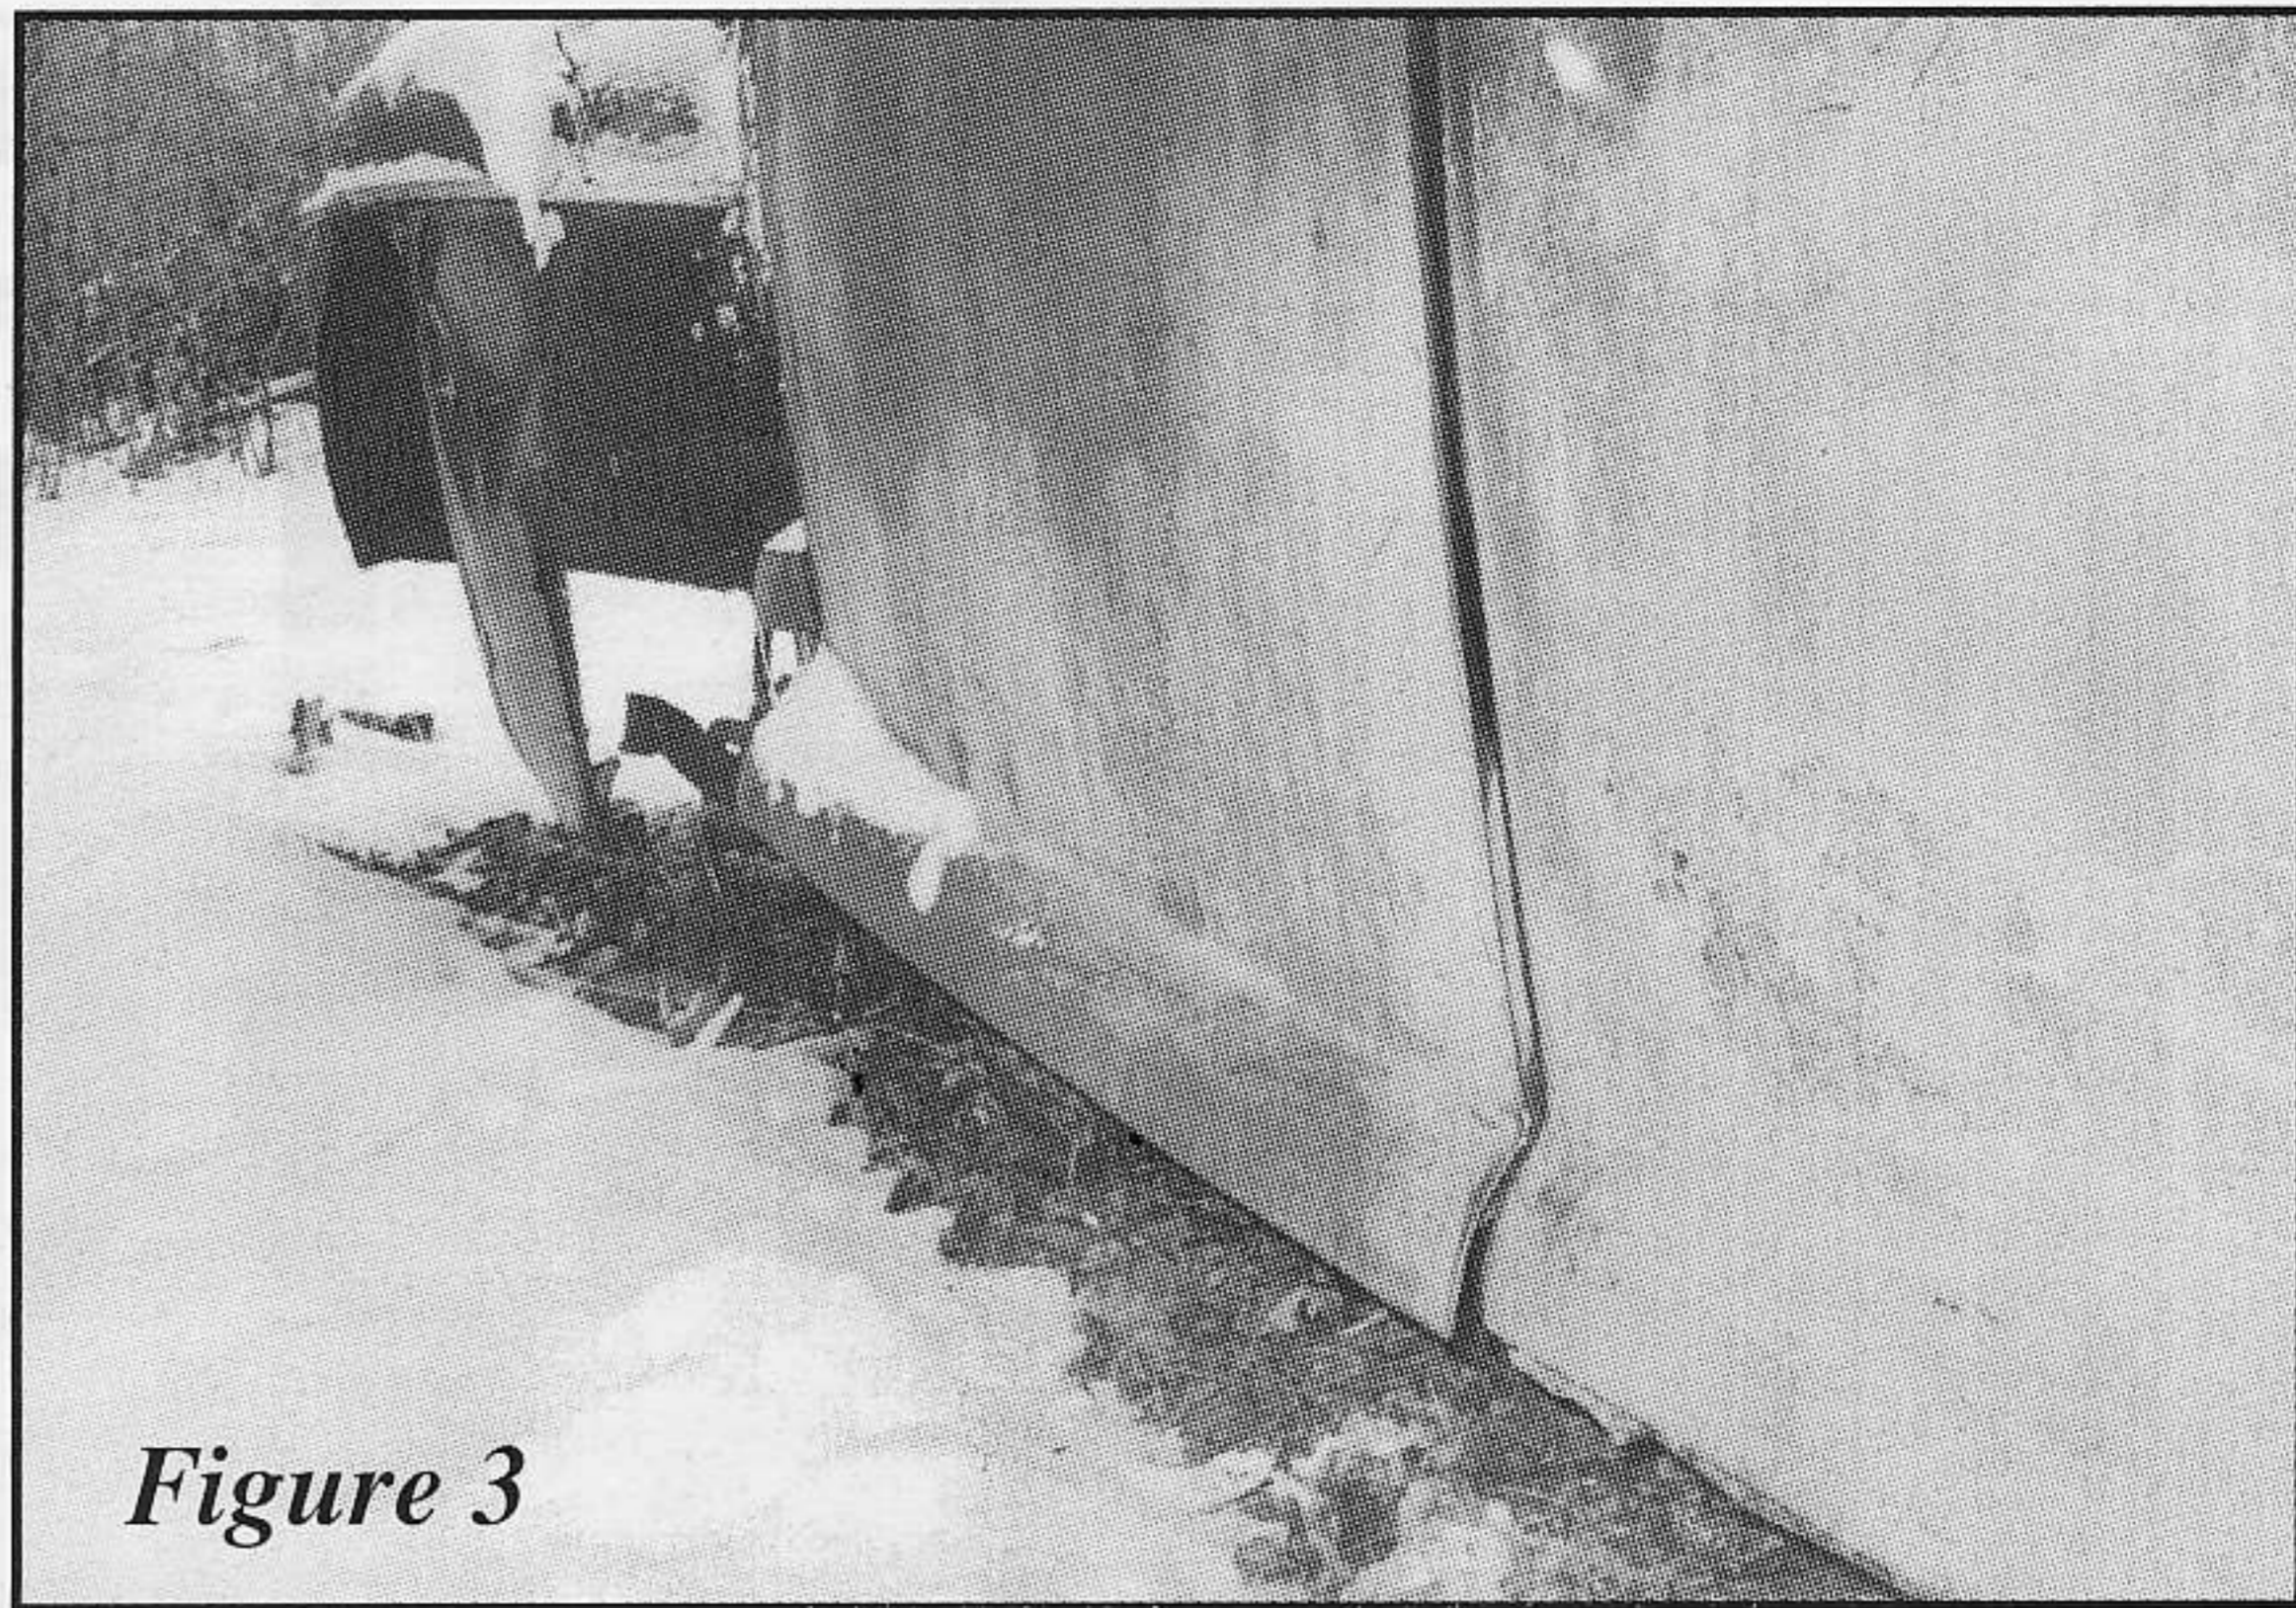
Figure 3

The brace in **Figure 3** is not bent, and the door does not line up.

Example of bad door alignment.

He cut the brace and welded a turnbuckle across the cut and drew the door in by tightening it. When he was happy with the fit he welded the brace where it was cut and removed the turnbuckle.

If you use this method it may require that you overstress the door as when the turnbuckle is relaxed the door will spring back some. Do not weld the brace completely on your first attempt. Tack weld it, loosen the turnbuckle and check alignment. You may have to cut the tack weld and tighten the turnbuckle further to get the result you want.
